RMA No.: 2644	[Final] 8D Report	Completed Report Date: 08/13/18
5101 Hidden Creek Lane Spicewood, TX 78669 USA		Customer:	Open Source Instruments	
Product:	MEMS Oscillator	Customer Contact:	Kevan Hashemi	
Part Number:	ASTMTXK-32.768KHZ-NG-T	Qty. Delivered:	4 units	
Affected D/C	1529	Qty. Rejected:		
Affected PO:		Qty. Returned for Analysis:	4 units	
Date Reported:	06/26/18	Distributor/Contract Manufacturer/Other:	Digikey

Failure Analysis Data:

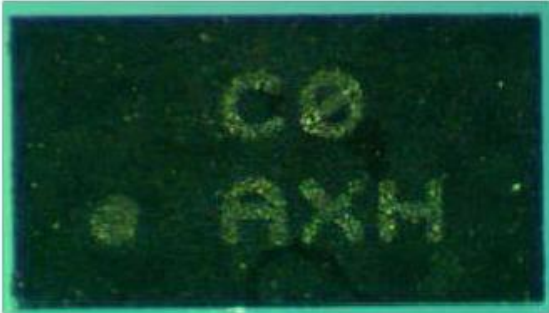
Top and bottom view inspection was done for all units. No obvious anomalies were found. The units were demounted units. Figure-1 and Figure-2 show the Incoming Inspection images for SN2, as an example.

Figure 1: Incoming Inspection SN2- Top View

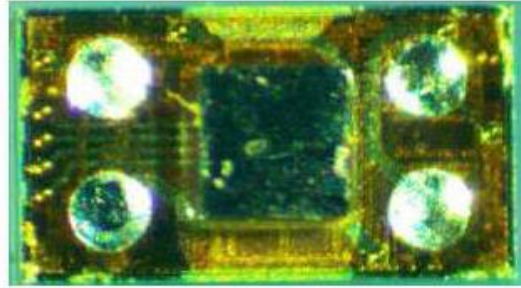
Figure 2: Incoming Inspection SN2- Bottom View

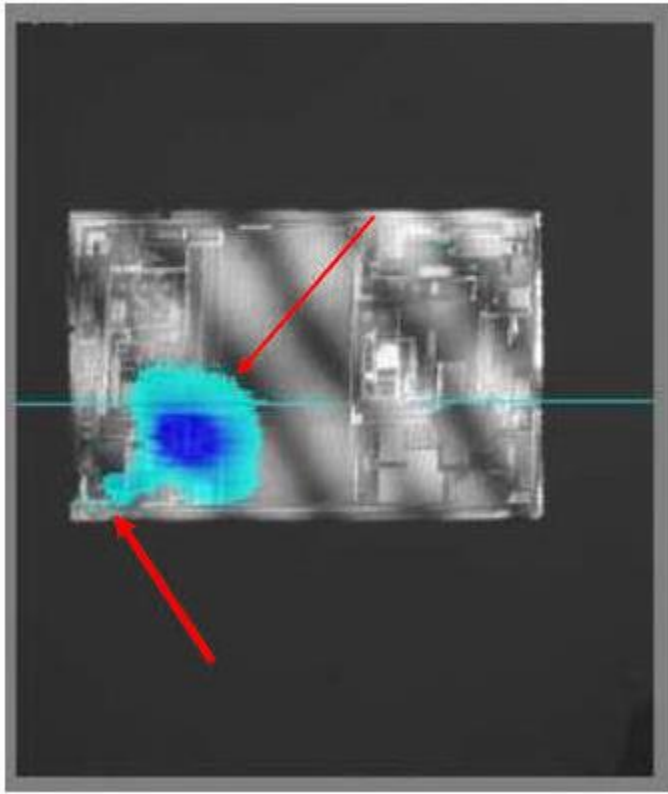
Chosen as a representative unit, SN4, which showed high current, was subjected to backside OBIRCH analysis and IR inspection. Obvious damage to CMOS die was observed in the area under the solder bumps of Vdd and GND. Figure-3-5 showed OBIRCH and IR images of the chipped/cracked silicon.

Figure 3: SN4, OBIRCH hot spot indicated by the arrows

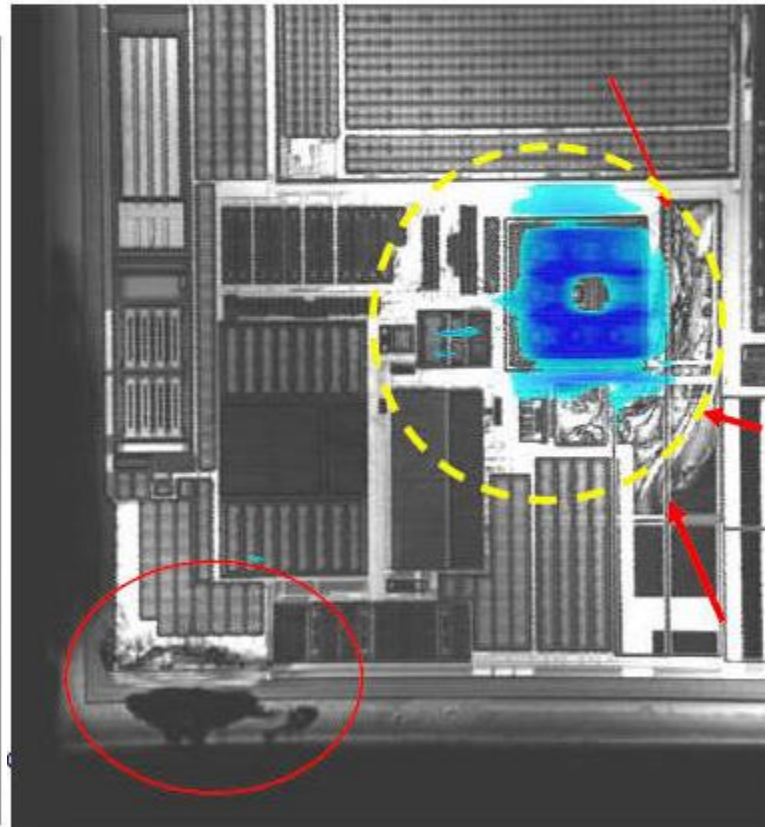
Figure 4: SN4, Zoom-in image of Figure 3. Chipped/cracked silicon was found at the area identified by OBIRCH hot spot indicated by the circle and the arrows. The damage was found in the area under the Vdd bump indicated by the broken circle. This image was taken from the backside of the CMOS as such the solder bump at the front side was not visible.

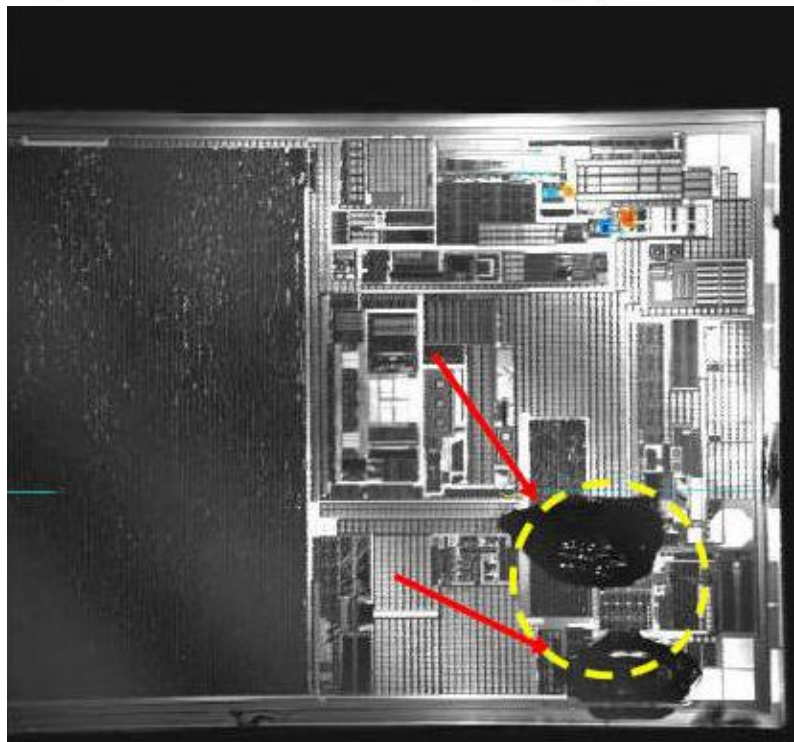
Figure 5: Cracked/chipped silicon was also observed in the area under the GND solder bump indicated by the arrows.

This image was taken from the back of the CMOS. The solder bump is in the front side of the CMOS which is not visible.

The broken circle indicated the location of the solder bump on the front side of the CMOS.
